A HIP REPLACEMENT FOR A LIFETIME: ALTERNATIVE BEARING SURFACES

Richard A. Sweet M.D.

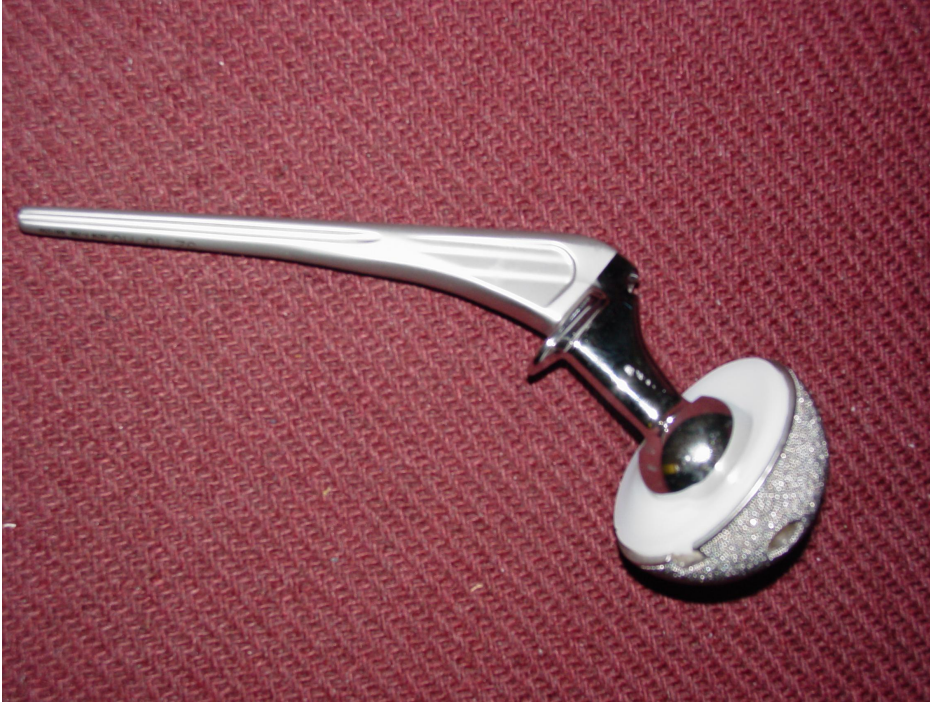
Figure 1. Metal on polyethylene articular bearing surface. It consists of a metal ball articulating with the polyethylene (plastic) cup which itself is fixed into a metal shell.

Historically the artificial hip has consisted of a cobalt-chrome metal ball (titanium is not used as it scratches when used as an articulating surface) articulating with a high density polyethylene (plastic) socket. The problem with this metal on plastic articulation has been that the metal ball is harder than the plastic socket causing the plastic to gradually “wear away”. The result is that small plastic wear particles are released into the joint. Often these plastic particles set up an inflammatory reaction causing cysts to develop in the bone and contribute to loosening of the implants. This cascade of events typically would occur over 10 to 15 years but were observed to occur at an accelerated pace and over a shorter time period in younger more active patients. Thus the search was on to eliminate the plastic and develop a new more wear resistant articulating surface.

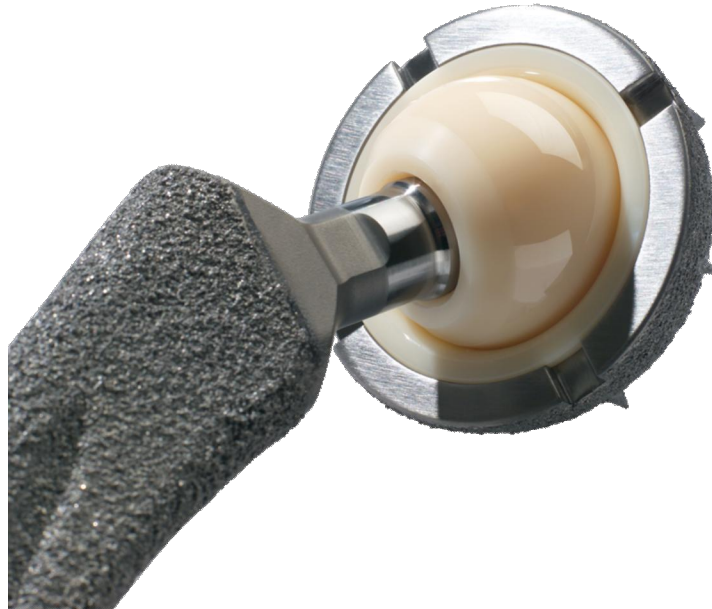
Figure 2. Ceramic on ceramic articular bearing surface. The ceramic femoral head articulates with the ceramic liner of the cup. The ceramic cup liner fits tightly into the metal shell of the cup.

Disadvantages exist, however. Ceramics are a form of glass and are somewhat brittle. If improperly designed, manufactured, or handled there is risk of the ceramic implant breaking. There is theoretic concern that as years pass, fracture of the ceramic implant might become an increasingly common problem. Revising a fractured ceramic implant is difficult due to the presence of many tiny "glass" fragments. And ceramic failures cannot be revised to another ceramic implant. Any revision requires a return to a metal on poly articulation.

A second major disadvantage in the use of ceramics is that due to current implant design constraints concerning femoral head size and socket depth, ceramic hip replacements will not be as stable as other alternatives. Thus there will a greater risk of hip dislocation after surgery. This is a significant drawback to the routine use of a ceramic on ceramic hip implant.

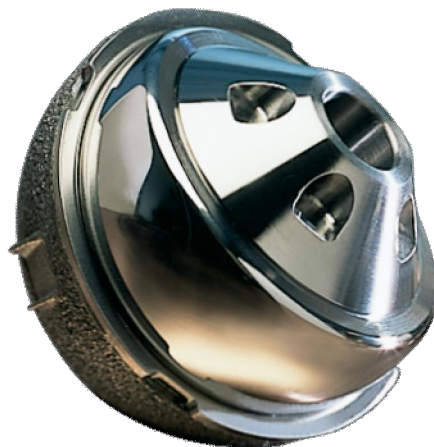
Figure 3. Metal on metal articular bearing surface. Note that the large femoral head is nearly as great in diameter as that of the normal bony hip. This large diameter increases hip stability reducing the risk of dislocation. A typical ceramic head is just over half this size.

(ball) can be made much larger and the socket thinner than with ceramics. The importance of the issue of head size is in its relationship to hip stability. The larger the diameter of the femoral head the more stable the hip and the less the risk of hip dislocation. Thus because of the larger femoral head size of the metal on metal designs (potentially almost twice as large as with ceramic implants) the THR can be made much more stable with less risk of dislocation.
